**Flood Control Project Maintenance
Levee Inspections**

Fall 2012 Levee Maintenance Deficiency Summary Report

San Joaquin River Basin

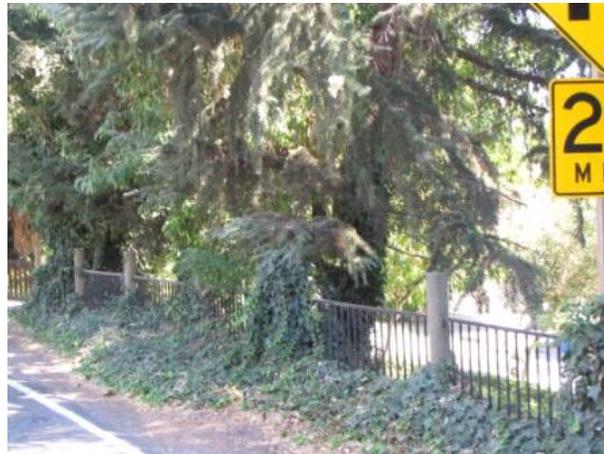
pkazi_f_20120913_495.jpg

Levee Mile Report Line	234
Start Levee Mile	22.17
End Levee Mile	22.18
Location	Land Side
Category	Earthen Levee
Item	Encroachments

View of a fence and landscaping along the landward shoulder and slope looking upstream.

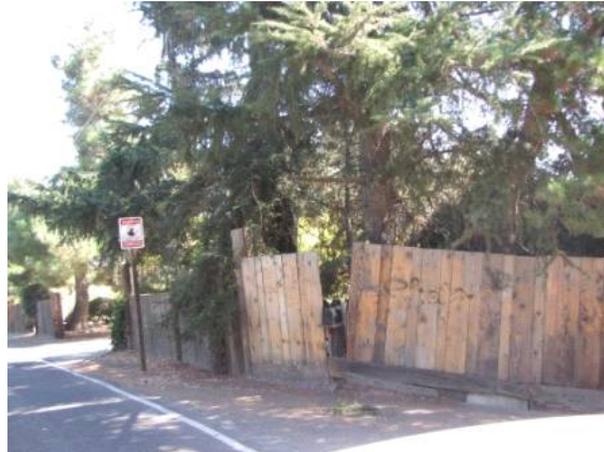
pkazi_f_20120913_494.jpg

Levee Mile Report Line	235
Start Levee Mile	22.19
End Levee Mile	22.21
Location	Land Side
Category	Earthen Levee
Item	Encroachments

View of a fence along the landward shoulder and slope looking upstream.

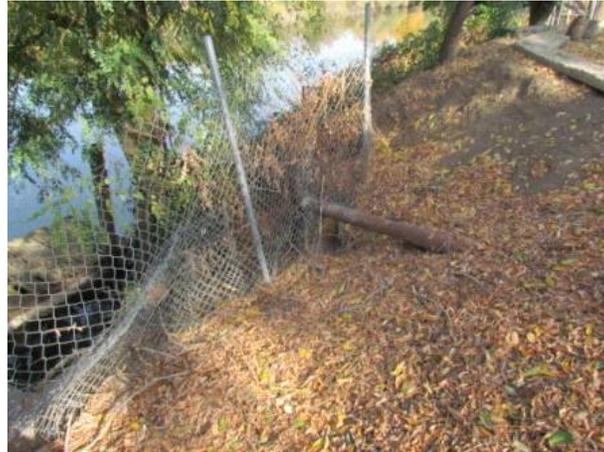
Levee Mile Report Line	237
Start Levee Mile	22.21
End Levee Mile	22.21
Location	Water Side
Category	Earthen Levee
Item	Encroachments
<p>An unpermitted abandoned pipe was found with electrical wires running through it on the waterside shoulder of the levee looking upstream.</p>	
<p>pkazi_f_20120913_487.jpg</p>

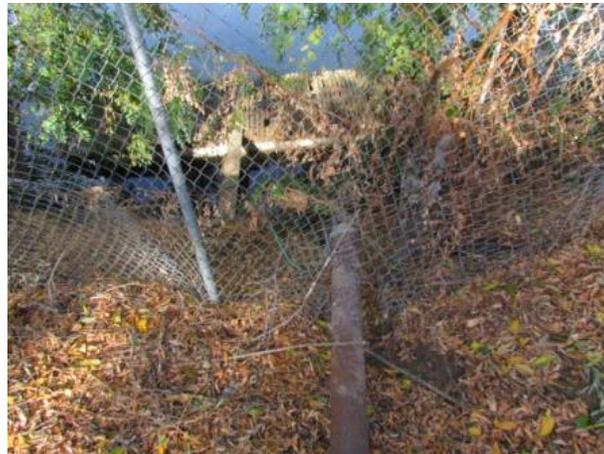
Levee Mile Report Line	237
Start Levee Mile	22.21
End Levee Mile	22.21
Location	Water Side
Category	Earthen Levee
Item	Encroachments
<p>View of the electrical wires through the pipe is found on the waterside of the levee. The picture was taken from the crown looking towards the toe of the levee.</p>	
<p>pkazi_f_20120913_488.jpg</p>

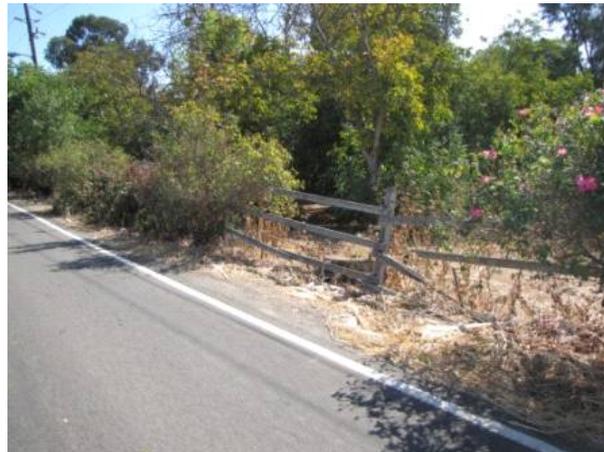
Levee Mile Report Line	238
Start Levee Mile	22.26
End Levee Mile	22.30
Location	Land Side
Category	Earthen Levee
Item	Encroachments
<p>View of a fence along the landward shoulder looking upstream.</p>	
<p>pkazi_f_20120913_493.jpg</p>

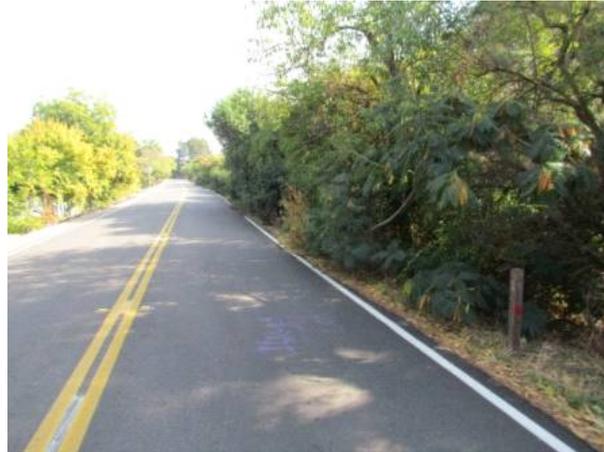
Levee Mile Report Line	239
Start Levee Mile	22.27
End Levee Mile	22.28
Location	Land Side
Category	Earthen Levee
Item	Vegetation
Landscaping was found on the landside of the levee looking upstream.	
pkazi_f_20120913_459.jpg

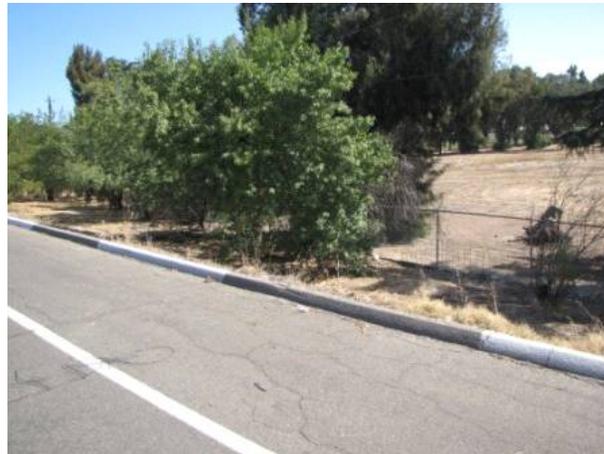
Levee Mile Report Line	240
Start Levee Mile	22.37
End Levee Mile	22.43
Location	Land Side
Category	Earthen Levee
Item	Encroachments
View of fence and landscaping along landward slope looking upstream.	
pkazi_f_20120913_490.jpg

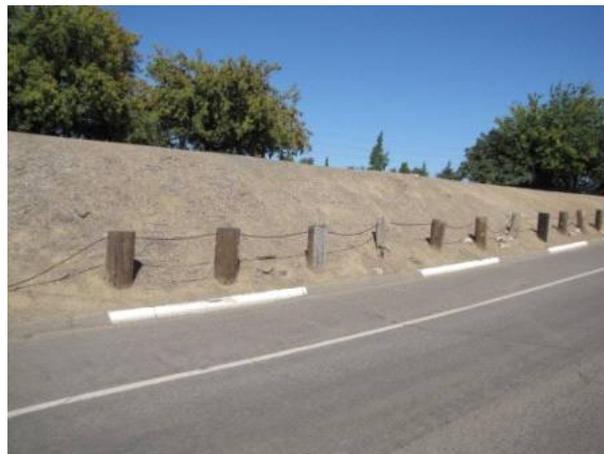
Levee Mile Report Line	242
Start Levee Mile	22.43
End Levee Mile	22.46
Location	Land Side
Category	Earthen Levee
Item	Encroachments
View of a post and cable fence along the landward slope looking upstream.	
pkazi_f_20120913_489.jpg

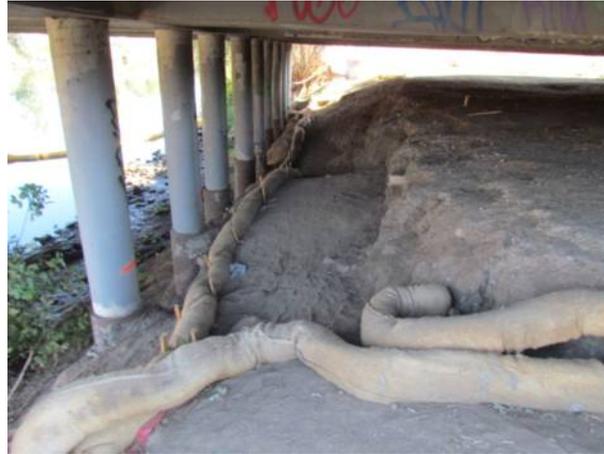
pkazi_f_20120913_449.jpg

View of the erosion under the I-5 bridge looking upstream.

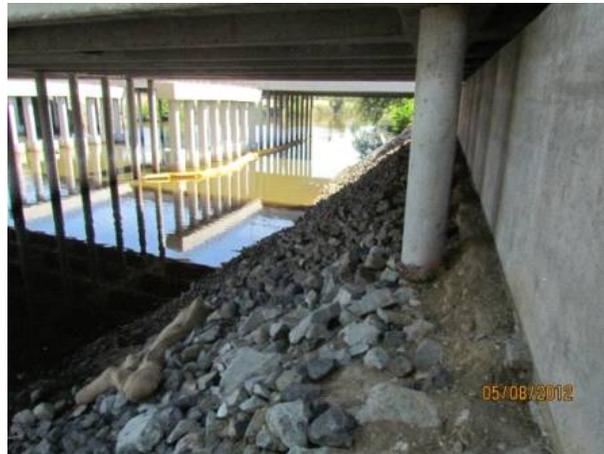
pkazi_f_20120913_450.jpg

Levee Mile Report Line	243
Start Levee Mile	22.52
End Levee Mile	22.52
Location	Water Side
Category	Earthen Levee
Item	Slope Stability

View of the erosion site repaired by Caltrans under the I-5 freeway going southbound. This picture was taken from the toe of the levee looking upstream.

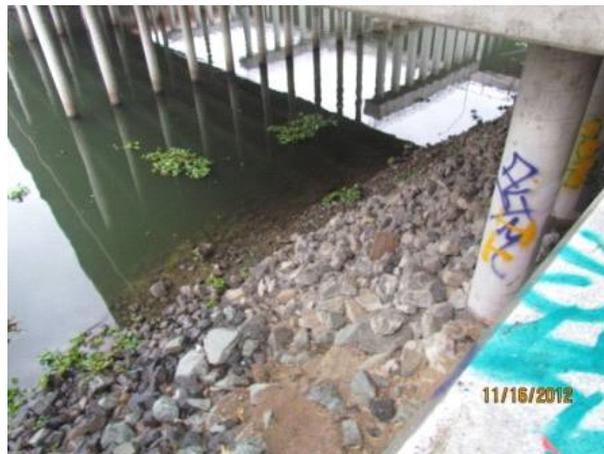
pkazi_f_20121120_102.jpg

Levee Mile Report Line	243
Start Levee Mile	22.52
End Levee Mile	22.52
Location	Water Side
Category	Earthen Levee
Item	Slope Stability

Updated view of the erosion site repaired by Caltrans on the waterside slope of the levee looking upstream.

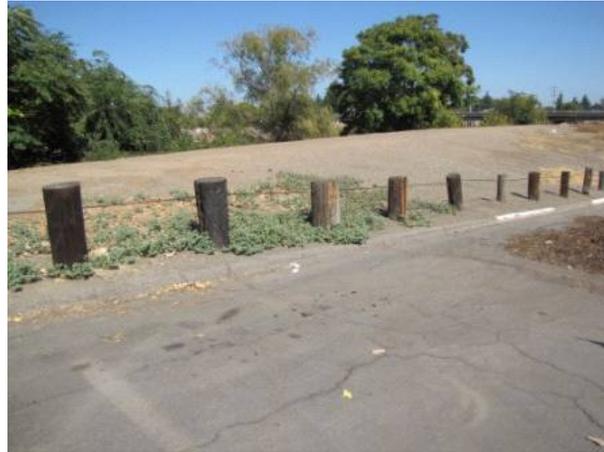
Levee Mile Report Line	244
Start Levee Mile	22.52
End Levee Mile	22.57
Location	Land Side
Category	Earthen Levee
Item	Encroachments
View of post and cable fence along the landward levee slope looking upstream.	
pkazi_f_20120913_486.jpg

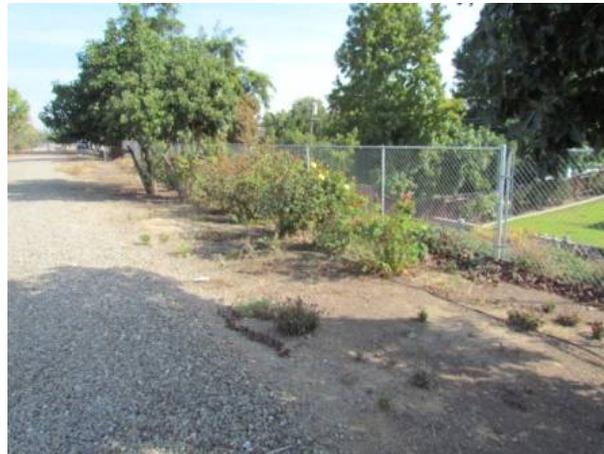
Levee Mile Report Line	245
Start Levee Mile	22.58
End Levee Mile	22.87
Location	Land Side
Category	Earthen Levee
Item	Vegetation
Landscape was found on the landside of the levee looking upstream.	
pkazi_f_20120913_483.jpg

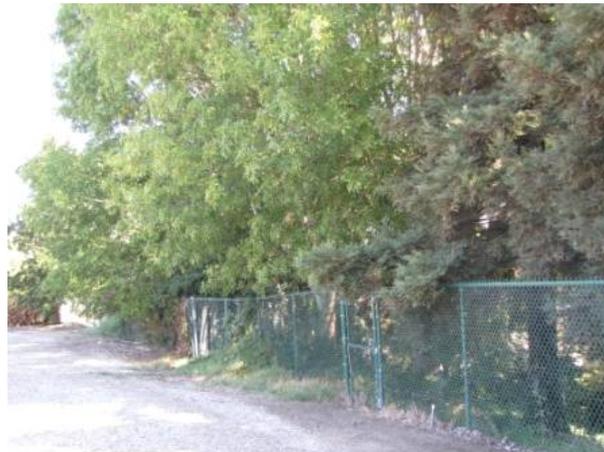
Levee Mile Report Line	246
Start Levee Mile	22.58
End Levee Mile	22.87
Location	Land Side
Category	Earthen Levee
Item	Encroachments
View of fence and landscaping along the landward shoulder and slope looking upstream.	
pkazi_f_20120913_482.jpg

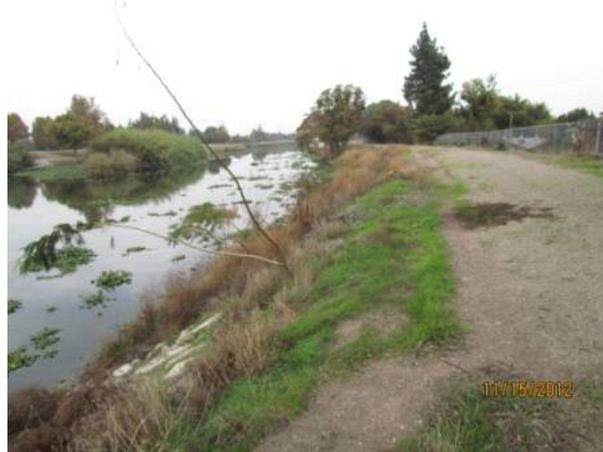
Levee Mile Report Line	247
Start Levee Mile	22.59
End Levee Mile	23.01
Location	Water Side
Category	Earthen Levee
Item	Vegetation
Vegetation was found on the waterside slope of the levee looking upstream.	
pkazi_f_20121120_101.jpg

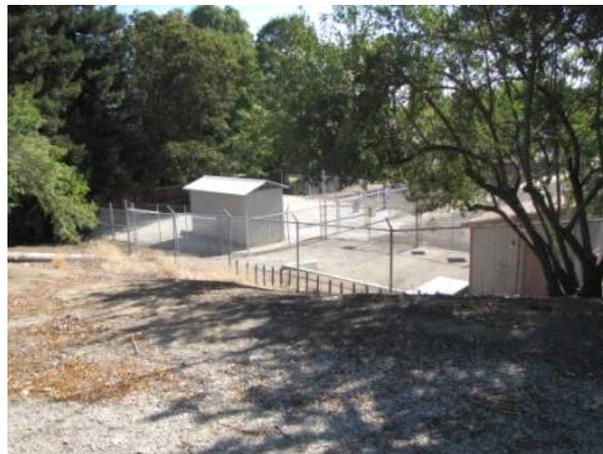
Levee Mile Report Line	248
Start Levee Mile	22.87
End Levee Mile	22.89
Location	Land Side
Category	Earthen Levee
Item	Encroachments
View of fence along the landward slope.	
pkazi_f_20120913_481.jpg

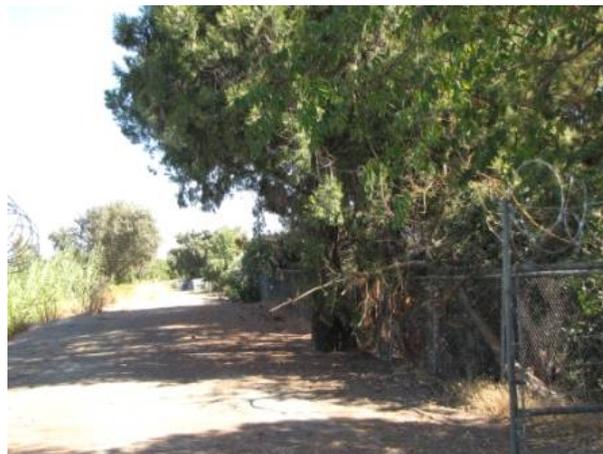
Levee Mile Report Line	251
Start Levee Mile	22.90
End Levee Mile	23.08
Location	Land Side
Category	Earthen Levee
Item	Encroachments
View of fence and landscaping along the landward shoulder looking upstream.	
pkazi_f_20120913_479.jpg

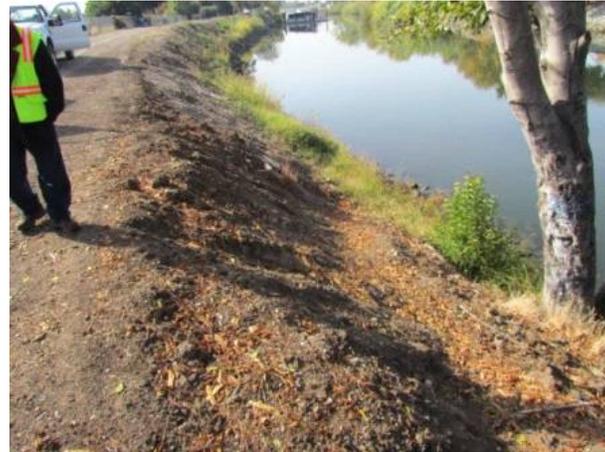
Levee Mile Report Line	252
Start Levee Mile	22.96
End Levee Mile	22.96
Location	Water Side
Category	Earthen Levee
Item	Slope Stability
Slope instability was found on the waterside of the levee looking downstream.	
pkazi_f_20120913_564.jpg

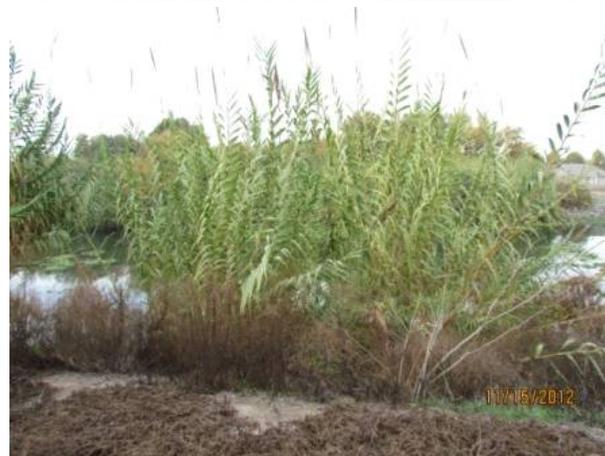
Levee Mile Report Line	253
Start Levee Mile	23.05
End Levee Mile	23.05
Location	Water Side
Category	Earthen Levee
Item	Vegetation
Arundo was found on the waterside slope of the levee looking upstream.	
pkazi_f_20121120_100.jpg

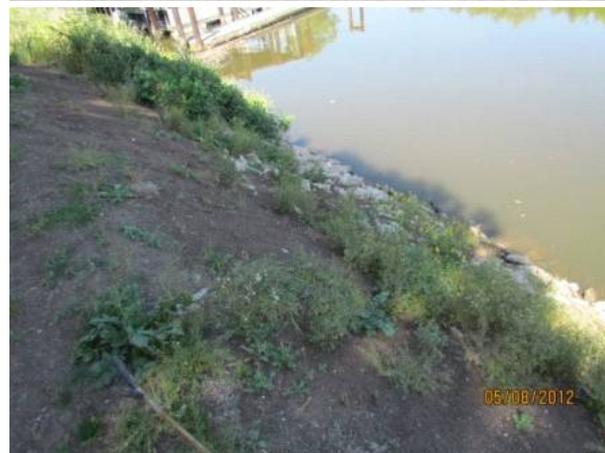
Levee Mile Report Line	255
Start Levee Mile	23.06
End Levee Mile	23.06
Location	Water Side
Category	Earthen Levee
Item	Slope Stability
Slope instability was repaired by the LMA on the waterside of the levee looking downstream.	
pkazi_f_20120913_447.jpg

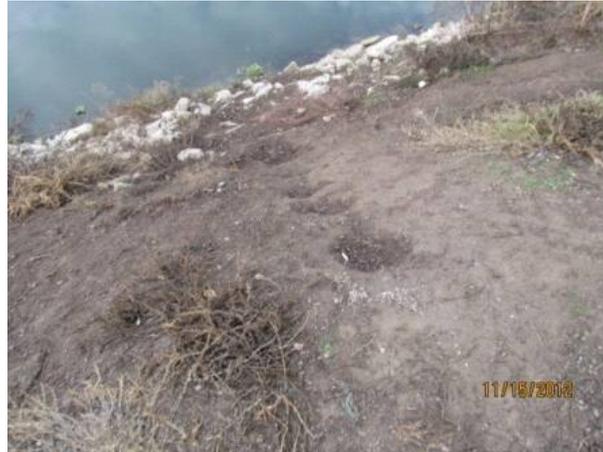
Levee Mile Report Line	256
Start Levee Mile	23.07
End Levee Mile	23.07
Location	Water Side
Category	Earthen Levee
Item	Encroachments
Steps were dug on to the waterside slope of the levee looking upstream.	
pkazi_f_20121120_099.jpg

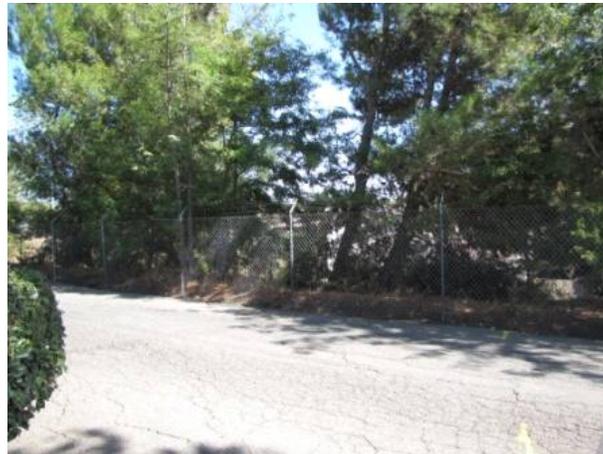
Levee Mile Report Line	257
Start Levee Mile	23.08
End Levee Mile	23.22
Location	Land Side
Category	Earthen Levee
Item	Encroachments
View of fence along the landward shoulder looking upstream.	
pkazi_f_20120913_477.jpg

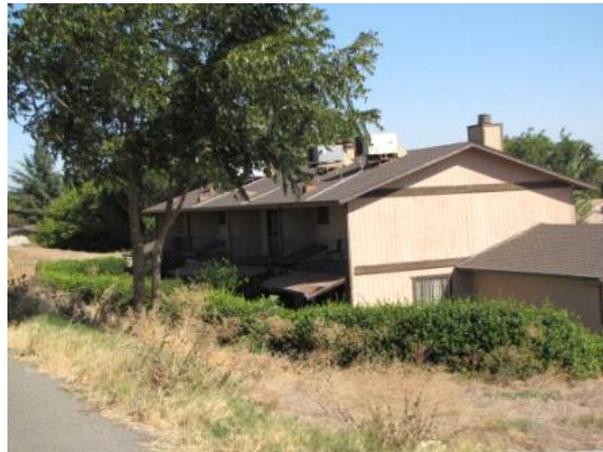
Levee Mile Report Line	258
Start Levee Mile	23.24
End Levee Mile	23.27
Location	Land Side
Category	Earthen Levee
Item	Vegetation
View of landscaping along the landward slope looking upstream.	
pkazi_f_20120913_476.jpg

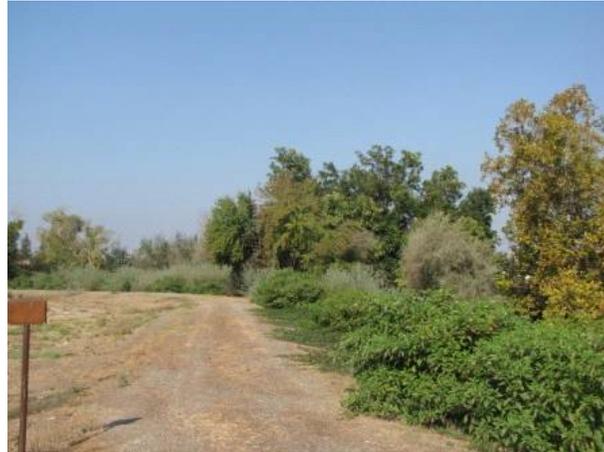
Levee Mile Report Line	261
Start Levee Mile	23.70
End Levee Mile	23.70
Location	Water Side
Category	Earthen Levee
Item	Encroachments
View of vegetation along the waterward slope looking downstream.	
pkazi_f_20120913_542.jpg

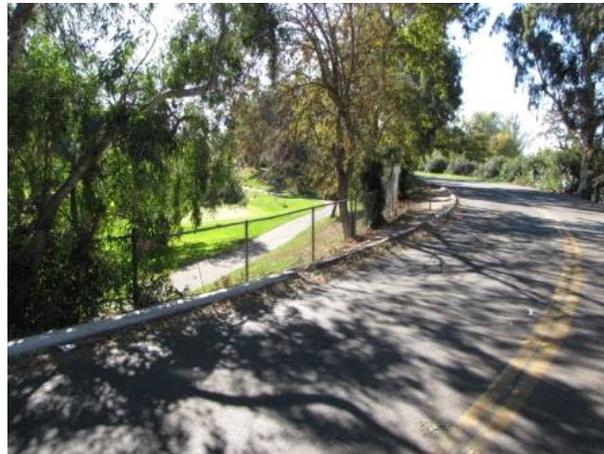
Levee Mile Report Line	263
Start Levee Mile	23.70
End Levee Mile	24.00
Location	Land Side
Category	Earthen Levee
Item	Encroachments
View of the fence along the landward slope looking downstream.	
pkazi_f_20120913_541.jpg

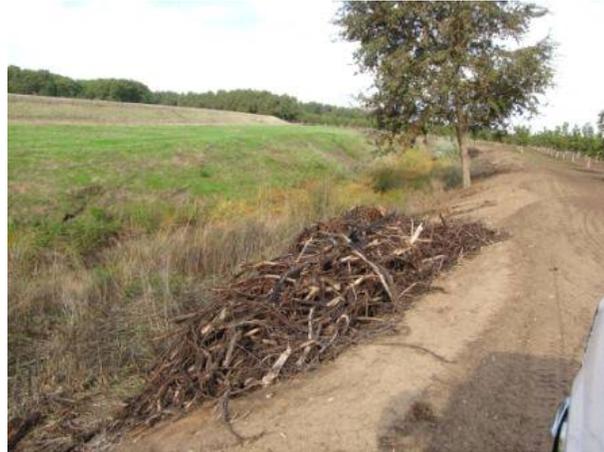
Levee Mile Report Line	1
Start Levee Mile	0.13
End Levee Mile	0.13
Location	Water Side
Category	Earthen Levee
Item	Encroachments
View of a prunings pile along the waterward bank looking downstream.	
pkazi_f_20120913_587.jpg

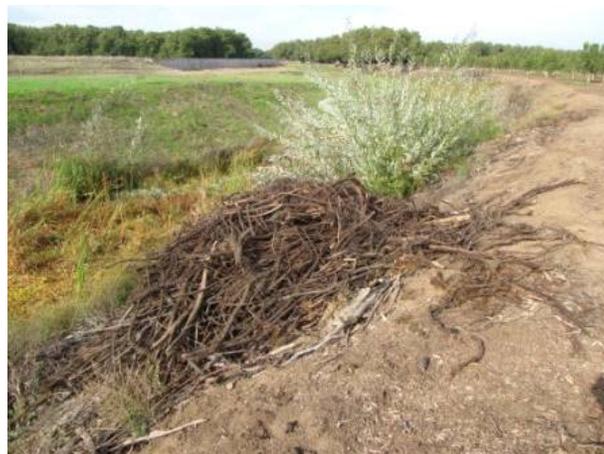
Levee Mile Report Line	2
Start Levee Mile	0.17
End Levee Mile	0.17
Location	Water Side
Category	Earthen Levee
Item	Encroachments
View of a prunings pile along the waterward bank looking downstream.	
pkazi_f_20120913_588.jpg

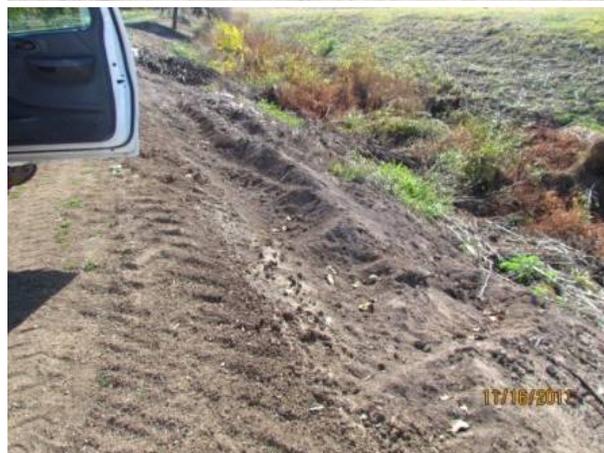
Levee Mile Report Line	3
Start Levee Mile	0.19
End Levee Mile	0.19
Location	Water Side
Category	Earthen Levee
Item	Slope Stability
Slope instability was found on the waterside of the levee looking upstream.	
pkazi_f_20120913_596.jpg

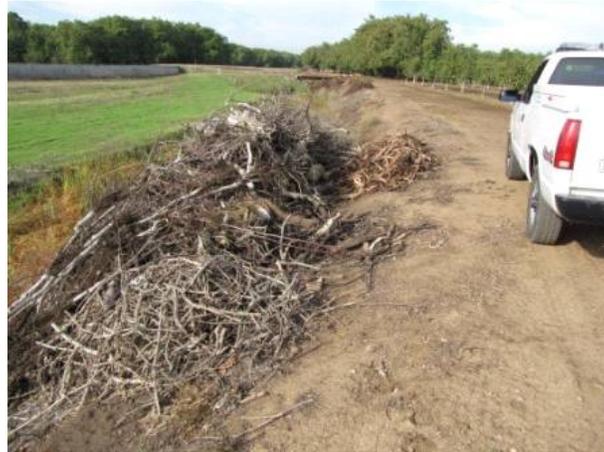
pkazi_f_20120913_589.jpg

View of a prunings pile along the waterward bank looking downstream.

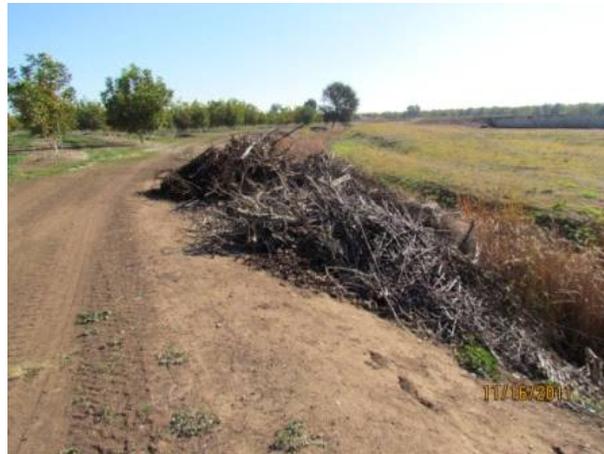
pkazi_f_20120913_590.jpg

Levee Mile Report Line	5
Start Levee Mile	0.25
End Levee Mile	0.25
Location	Water Side
Category	Earthen Levee
Item	Encroachments

Prunings were found on the waterside of the levee looking upstream.

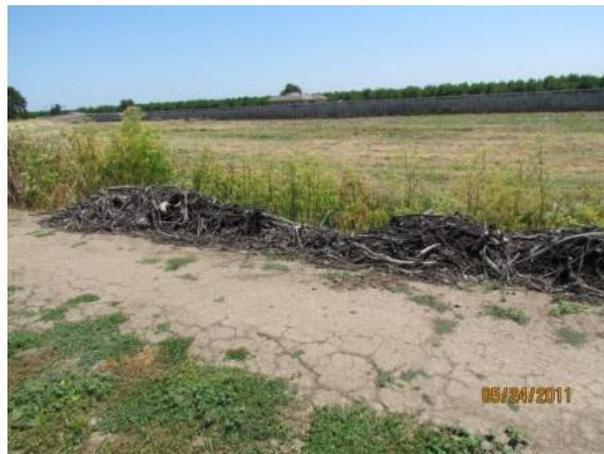
pkazi_f_20120913_591.jpg

Levee Mile Report Line	7
Start Levee Mile	0.27
End Levee Mile	0.27
Location	Water Side
Category	Earthen Levee
Item	Encroachments

Prunings was found on the waterside of the levee. The picture was taken from the crown looking upstream.

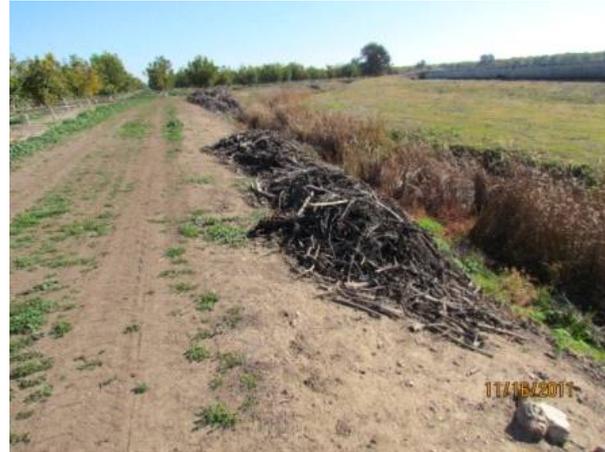
Levee Mile Report Line	7
Start Levee Mile	0.27
End Levee Mile	0.27
Location	Water Side
Category	Earthen Levee
Item	Encroachments
<p>Prunings were found on the waterside of the levee looking upstream. This picture was taken during fall 2011 inspection.</p>	
<p>pkazi_f_20120913_592.jpg</p>

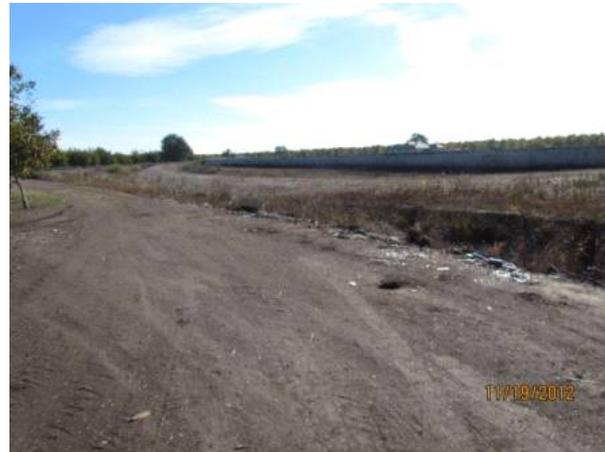
Levee Mile Report Line	8
Start Levee Mile	0.28
End Levee Mile	0.28
Location	Water Side
Category	Earthen Levee
Item	Encroachments
<p>Debris was cleaned by the LMA on the waterside shoulder of the levee looking upstream.</p>	
<p>pkazi_f_20121121_133.jpg</p>

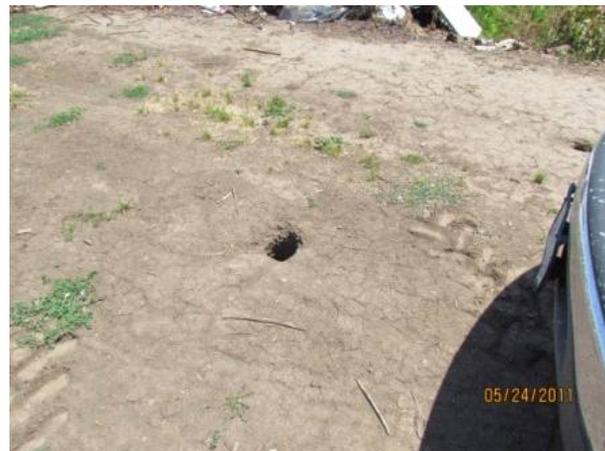
Levee Mile Report Line	10
Start Levee Mile	0.28
End Levee Mile	0.28
Location	Crown
Category	Earthen Levee
Item	Animal Control
<p>A rodent hole was found on the crown of the levee. The picture was taken from the crown looking upstream.</p>	
<p>pkazi_f_20120913_593.jpg</p>

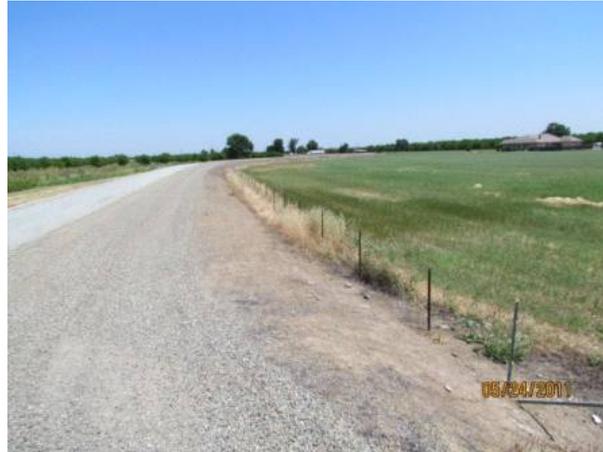
Levee Mile Report Line	2
Start Levee Mile	0.08
End Levee Mile	0.29
Location	Land Side
Category	Earthen Levee
Item	Encroachments
<p>Fences along the landside toe of the levee. The picture was taken from the crown looking upstream.</p>	
<p>pkazi_f_20120913_597.jpg</p>

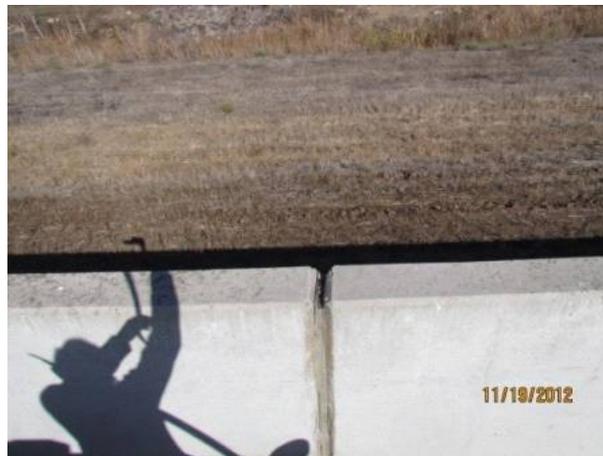
Levee Mile Report Line	3
Start Levee Mile	0.26
End Levee Mile	0.26
Location	Water Side
Category	Concrete Floodwalls
Item	Monolith Joints
<p>The monolith joint material was deteriorating and steel plate was exposed between the joints. The picture was taken from the crown looking towards the toe of the levee.</p>	
<p>pkazi_f_20121121_132.jpg</p>
